Inspection Report

Property Address: 123 Main Street Anywhere New York 11222

The House Detective Home Inspection Agency

Date: 7/7/2021	Time:	Report ID: 070721-Sample Report
Property:	Customer:	Real Estate Professional:
123 Main Street	Mr. John Doe	
Anywhere New York 11222

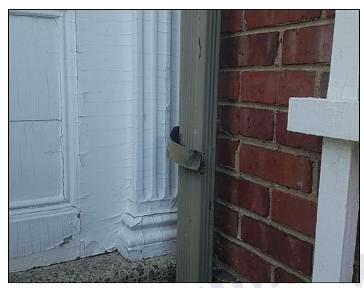
1.2 Item 1(Picture)

(1) Gutters and downspouts are in need of repair or replacement at areas. The rear gutter leaks at the center seam and many of the downspouts are loose.

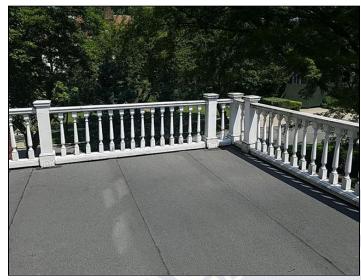
1.3 Item 1(Picture)

Roofing materials at the two roof deck areas are in serviceable condition however decking is recommended to eliminate walking on the material. The main concern here is the height of the railings which does not conform to todays safety standards and should be corrected.

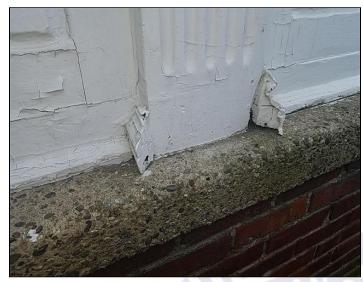
2.0 Item 1(Picture)

(1) A large majority of the wood coverings and trim at the exterior is deteriorated due to many years of moisture absorption and in need of replacement. Further deterioration will occur and eventually cause further issues within the wall cavity if left as is...

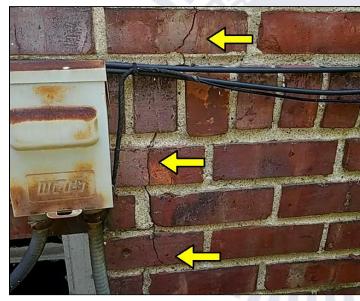
2.0 Item 14(Picture)

(3) Vertical crack in the brick at the area behind the air conditioning condensing units is noted. Further separation will occur over time. Repair needed.

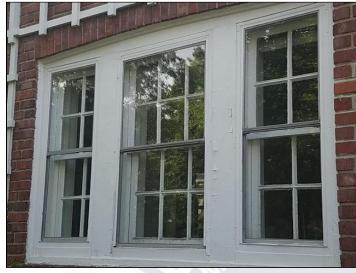
2.2 Item 1(Picture)

(1) Aged single pane windows of little or no insulating value, several of which are difficult to operate and loosely attached are present thruout the home. These windows will likely allow cold air infiltration into the home in the winter. I recommend replacement with energy efficient thermal insulated windows for comfort and energy conservation. Many of the wood frames are peeling paint and have bare wood exposed as well therefore I also recommend that during the replacement of the windows that the contractor cap all exterior wood framing components with aluminum for protection against deterioration.

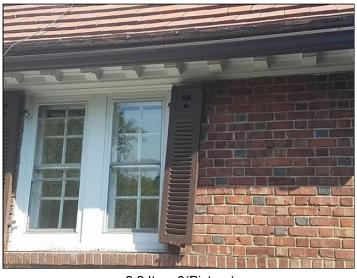
2.2 Item 3(Picture)

(2) Shutters are old, and the brackets are likely deteriorating, causing deflection of the shutters. Repairs needed.

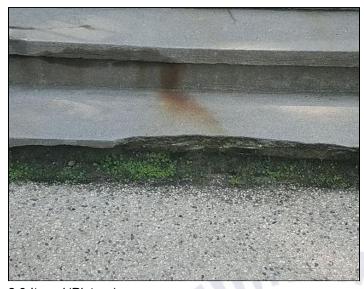
2.3 Item 1(Picture)

The front entry steps are cracked and deteriorated in areas. Also of note is deterioration at the iron railings. Repairs are recommended.

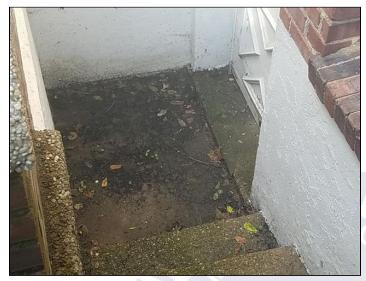
2.4 Item 1(Picture)

(1) a section of the driveway is pitched towards the exterior basement entrance area. The ground drain in this area appears to be totally clogged and filled with debris. This can result in water infiltration at the basement entry area. Correction needed.

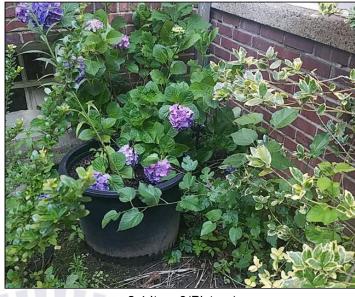
2.4 Item 3(Picture)

(2) There is a negative slope at the perimeter of the home at areas and can cause or contribute to water intrusion or deterioration. I recommend correcting landscape to drain water away from home.

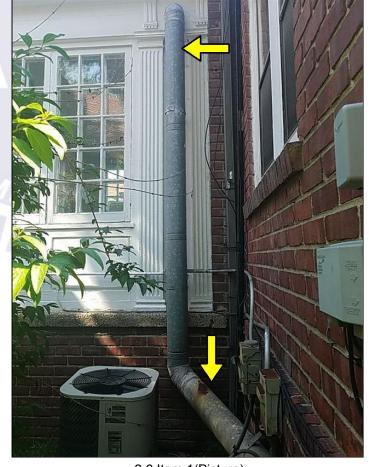
2.6 Item 1(Picture)

(1) Air conditioning duct is installed at the exterior and not insulated. This will result in fluctuating temperature. I recommend correction.

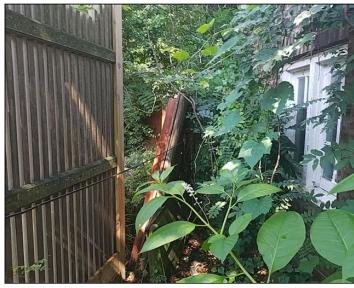
2.6 Item 2(Picture)

(2) Fencing at the area behind the garage is leaning and in need of repair. Unknown if this is your fence of the neighbors...

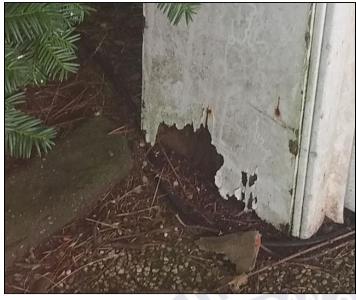
3.0 Item 1(Picture)

The garage is in need of a complete renovation. Roof leakage, roof rafter deterioration, brick and mortar deterioration and minor electrical work is noted. Consult with a qualified contractor

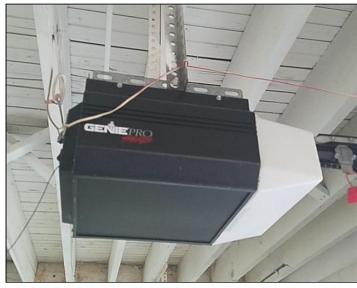
3.2 Item 1(Picture)

Garage door did reverse at the motion the sensors however, the pressure switch is not functioning. Service recommended.

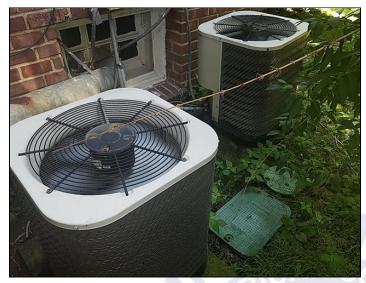
5.5 Item 1(Picture)

Both air conditioning systems did turn on, however did not supply cold air to the home. Temperature differential should be near 18 degrees and the best these systems did was 4 degrees indicating service is needed. These are older systems that are serviced with R22 refrigerant which is no longer manufactured and difficult to aquire, therefore I recommend consulting with an HVAC technician.

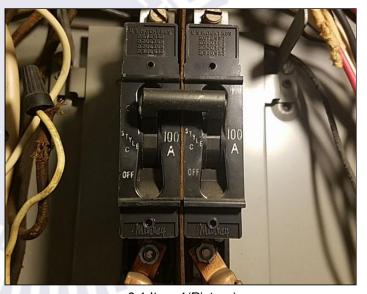
6.1 Item 1(Picture)

The electrical service for this home is undersized by today's standards with several deficiencies found. A licensed electrician is recommended to evaluate for an upgrade at the panel and branch circuitry. A minimum 200 amp, 220 service is recommended for a home of this size

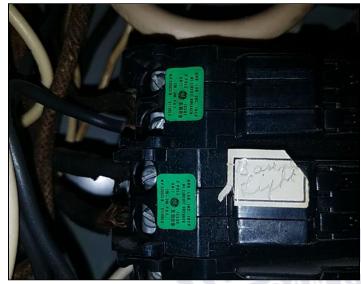
6.2 Item 1(Picture)

The problem discovered in the panel is doubled wiring, open ended wiring and old cloth wiring as well as all other issues noted within this report or other concerns requiring correcting should be performed by a licensed electrician I recommend a licensed electrician

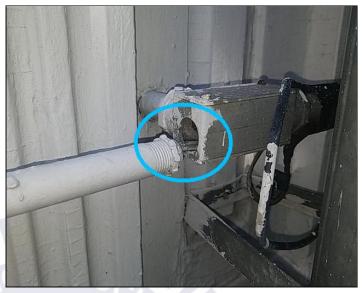
6.3 Item 1(Picture)

(1) Loose conduit at the exterior is exposing wiring and needs to be reattached to the junction box

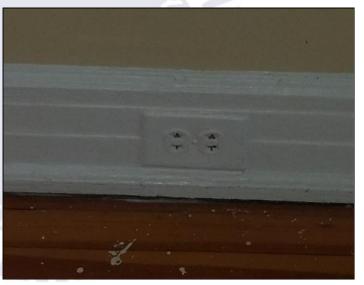
6.3 Item 2(Picture)

(2) "Two-prong" outlets are inadequate, non grounded and not up to today's standards in areas. A qualified licensed electrician should be consulted and should correct as needed. Be advised that the conceal;ed electrical wiring within the walls and ceilings is likely original to the homes construction and should be evaluated by the electrician as well.

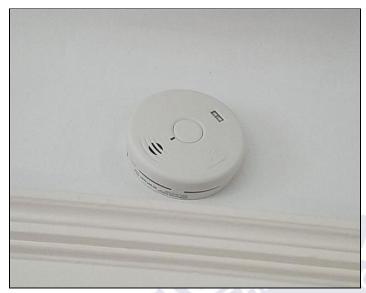
6.6 Item 1(Picture)

I recommend installing <u>new</u> smoke and carbon monoxide detectors at each level and in each sleeping area in accordance with the manufacturers directions. Because carbon monoxide is much heavier than air and therefor will fill a room from the bottom, up. An additional co detector should be placed on the wall at each level in accordance with manufacturers instructions for safety.

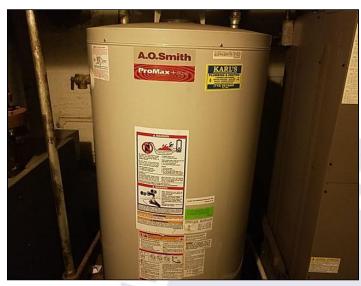
7.2 Item 1(Picture)

Hot water tanks in general have a life expectancy of between 8 and 12 years. The system presently installed was manufactured in 2006, placing it past it's life expectancy and although operating as intended I recommend replacement prior to failure. The pressure relief valve located at or near the top of the tank is a safety device that allows hot water and steam to escape should the pressure become too high. A (metal) pipe extension is required to extend to within 2 to 6 inches from the floor to prevent accidental scalding should the tank become over pressurized. I recommend operating this valve every 6 months to ensure it's correct operation. If the valve does not open or close properly it should be replaced. I further recommend draining the bottom of the tank annually to reduce sediment buildup.

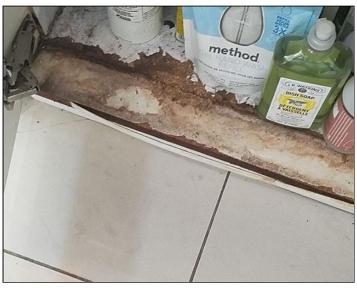
9.1 Item 1(Picture)

Sink base is deteriorated due to past water leakage. All dry at this time. Repair or replace as needed.

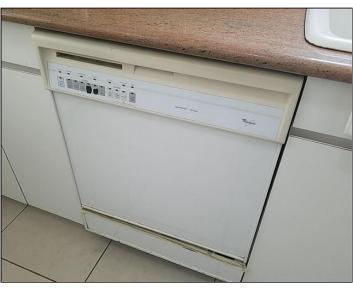
9.4 Item 1(Picture)

Advised that this appliance needs replacement therefore not tested.

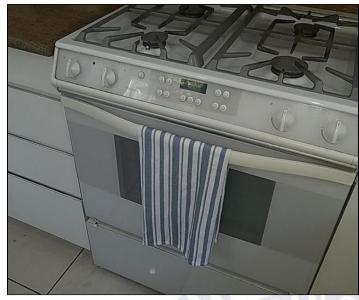
9.5 Item 1(Picture)

Left rear top burner did not light at the range requiring repair, and the wall oven display is difficult to see therefore I was unable to test this appliance.

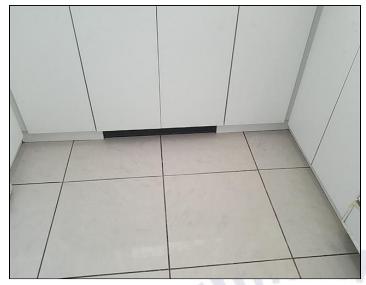
9.10 Item 1(Picture)

Electric baseboard heater under the cabinet did not function and the control knob is loose at the wall.
Repair recommended.

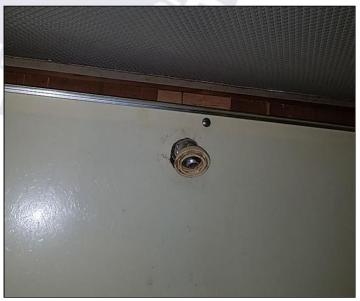
10.2.A Item 1(Picture)

Shower head needs installation.

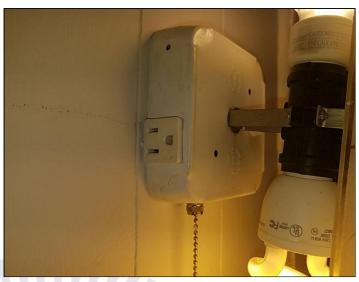
10.3.A Item 1(Picture)

Built in outlets at bathroom light fixtures should not be used due to their location, usually directly over the sink. I recommend installing at the wall switch a GFCI outlet for safety.

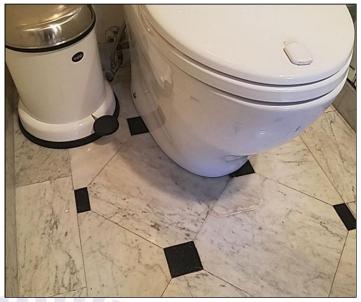
10.2.B Item 1(Picture)

The toilet was loose and needs to be secured.. This should be done by a qualified person.

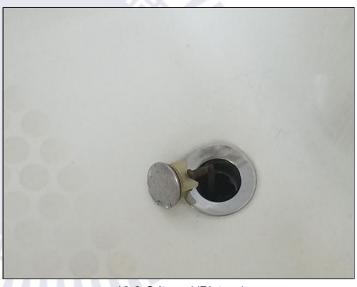
10.2.C Item 1(Picture)

(1) The stop-valve and linkage does not work properly and needs adjustment at the bath tub. . A qualified person should repair as necessary.

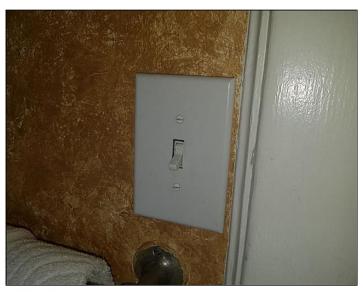
10.3.E Item 1(Picture)

There is no outlet found in bath. I recommend a duplex GFCI outlet be installed by a licensed electrician which will eliminate the need for an extension cord.
