Inspection Report

Property Address: 123 Main Street Anywhere New York 11222

The House Detective Home Inspection Agency

Date: 7/7/2021	Time:	Report ID: 070721-Sample Report
Property:	Customer:	Real Estate Professional:
123 Main Street	Mr. John Doe	
Anywhere New York 11222

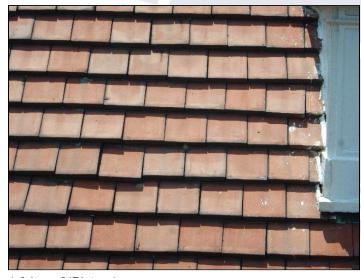
1.0 Item 2(Picture)

Clay tile roof requires periodic inspection to determine stability of tiles. This type of material can function adequately for up to 100 years with proper maintenance. The material is beginning to show signs of weathering however there were no active leaks observed at this time. The tiles appear serviceable at this time however the likelihood for the need of repairs or replacement within 15 years exists. I recommend evaluation by a specialized slate roofing professional every 3 to 5 years.

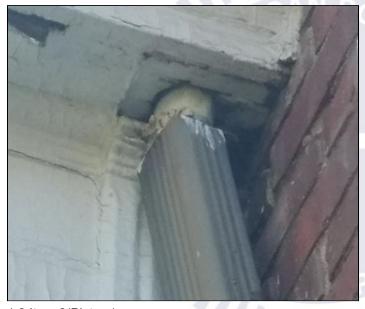
1.2 Item 2(Picture)

(1) Gutters and downspouts are in need of repair or replacement at areas. The rear gutter leaks at the center seam and many of the downspouts are loose.

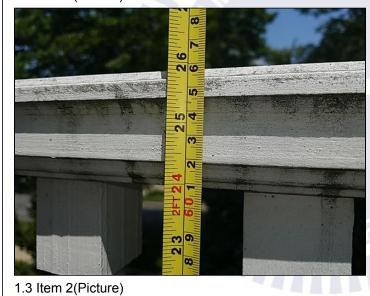
1.3 Item 2(Picture)

Roofing materials at the two roof deck areas are in serviceable condition however decking is recommended to eliminate walking on the material. The main concern here is the height of the railings which does not conform to todays safety standards and should be corrected.

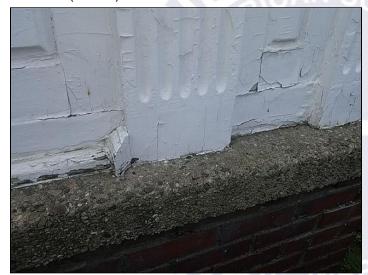
2.0 Item 2(Picture)

(1) A large majority of the wood coverings and trim at the exterior is deteriorated due to many years of moisture absorption and in need of replacement. Further deterioration will occur and eventually cause further issues within the wall cavity if left as is...

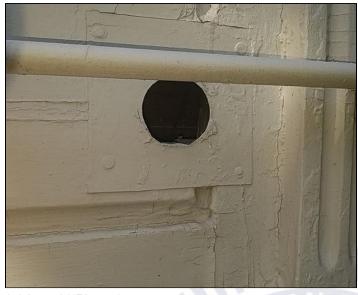
2.0 Item 11(Picture)

(2) Openings in the siding at the rear and side of the home should be covered to eliminate the potential for bird or squirrel nesting.

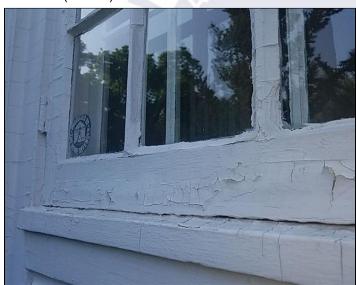
2.2 Item 2(Picture)

(1) Aged single pane windows of little or no insulating value, several of which are difficult to operate and loosely attached are present thruout the home. These windows will likely allow cold air infiltration into the home in the winter. I recommend replacement with energy efficient thermal insulated windows for comfort and energy conservation. Many of the wood frames are peeling paint and have bare wood exposed as well therefore I also recommend that during the replacement of the windows that the contractor cap all exterior wood framing components with aluminum for protection against deterioration.

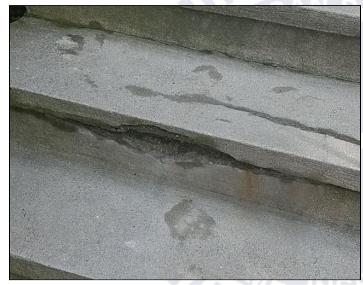
2.3 Item 2(Picture)

The front entry steps are cracked and deteriorated in areas. Also of note is deterioration at the iron railings. Repairs are recommended.

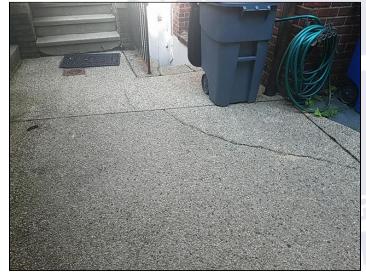
2.4 Item 2(Picture)

(1) a section of the driveway is pitched towards the exterior basement entrance area. The ground drain in this area appears to be totally clogged and filled with debris. This can result in water infiltration at the basement entry area. Correction needed.

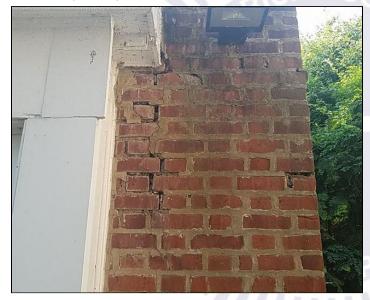
3.0 Item 2(Picture)

The garage is in need of a complete renovation. Roof leakage, roof rafter deterioration, brick and mortar deterioration and minor electrical work is noted. Consult with a qualified contractor

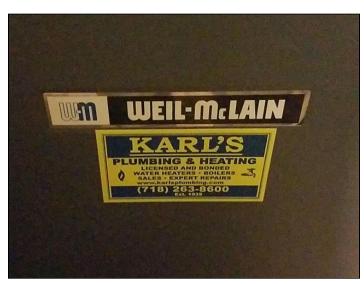
5.0 Item 1(Picture)

There is a Weil McLain, steam boiler presently installed and functioning. Systems such as this have a general life expectancy of between 30 and 40 years providing they have been properly maintained. I recommend securing a service contract with a local utility for maintenance and service when the need arises. Please follow manufactures maintenance recommendations..

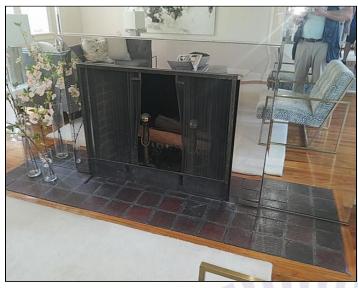
5.3 Item 1(Picture)

Satisfactory however cleaning is needed by a qualified chimney sweep prior to use.

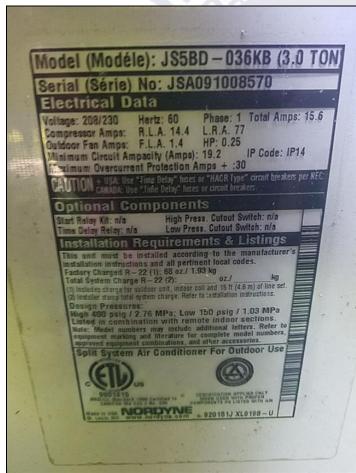
5.5 Item 2(Picture)

Both air conditioning systems did turn on, however did not supply cold air to the home. Temperature differential should be near 18 degrees and the best these systems did was 4 degrees indicating service is needed. These are older systems that are serviced with R22 refrigerant which is no longer manufactured and difficult to aquire, therefore I recommend consulting with an HVAC technician.

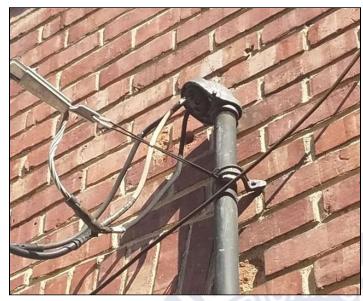
6.0 Item 1(Picture)

The service mast needs additional strapping to secure the service and the bottom of the mast is open, exposing the electrical wires which needs a cover. Additionally, vegetation growing onto the wires should be cleared to reduce tension.

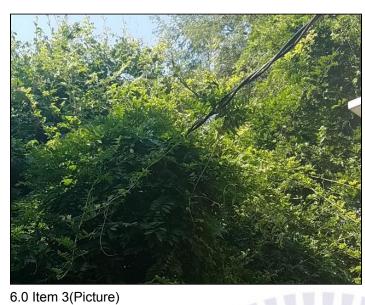
The electrical service for this home is undersized by today's standards with several deficiencies found. A licensed electrician is recommended to evaluate for an upgrade at the panel and branch circuitry. A minimum 200 amp, 220 service is recommended for a home of this size

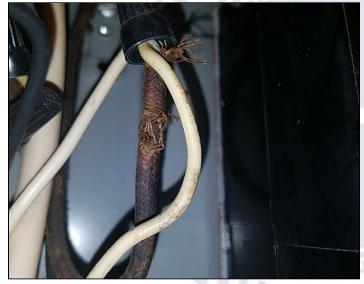
6.2 Item 1(Picture)

The problem discovered in the panel is doubled wiring, open ended wiring and old cloth wiring as well as all other issues noted within this report or other concerns requiring correcting should be performed by a licensed electrician I recommend a licensed electrician

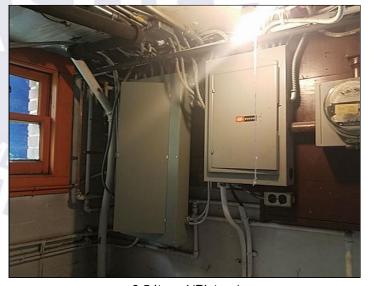
6.5 Item 1(Picture)

The main panel boxes are located at the basement.

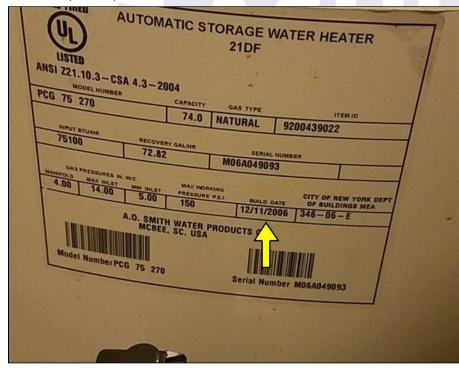
7.2 Item 2(Picture)

Hot water tanks in general have a life expectancy of between 8 and 12 years. The system presently installed was manufactured in 2006, placing it past it's life expectancy and although operating as intended I recommend replacement prior to failure. The pressure relief valve located at or near the top of the tank is a safety device that allows hot water and steam to escape should the pressure become too high. A (metal) pipe extension is required to extend to within 2 to 6 inches from the floor to prevent accidental scalding should the tank become over pressurized. I recommend operating this valve every 6 months to ensure it's correct operation. If the valve does not open or close properly it should be replaced. I further recommend draining the bottom of the tank annually to reduce sediment buildup.

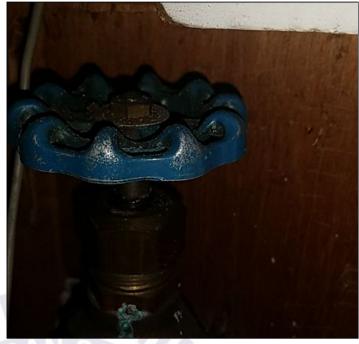
7.3 Item 1(Picture)

The main shut off is the blue valve located in the basement near the water meter.. This is for your information.

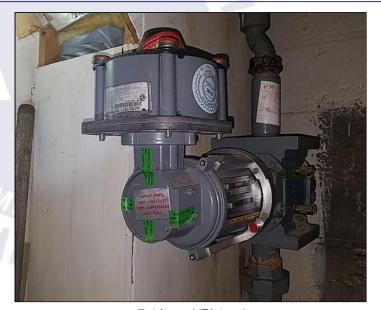
7.4 Item 1(Picture)

Serviceable, The visible, readily accessible gas piping and connections were evaluated with no issues discovered at the time of the inspection. Gas pipe leaks are usually contributed to dried out sealant which occurs over an extended period of time. A more evasive pressure test by a licensed plumber could possibly uncover any gas leaks at components concealed within the walls and ceilings, and is recommended if the gas has been off at the time of the inspection. This type of testing takes several hours and is conducted by a licensed plumber. This is for your information.

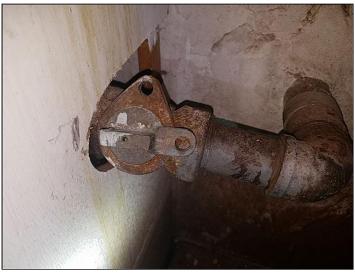
7.5 Item 1(Picture)

The gas shutoff is at the gas meter in the basement. Keep a properly sized wrench attached to the meter and know how to turn the system off in case of an emergency. The gas to the entire home can be shut off from this valve in the event of an emergency.

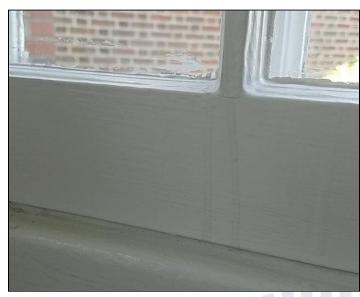
8.0 Item 3(Picture)

Slight water staining is visible under the window at the right side main floor study. This area is dry however staining may have occurred at the window, during a directional rain. Monitor and if necessary repair as needed. 8.0 Item 1(Picture)

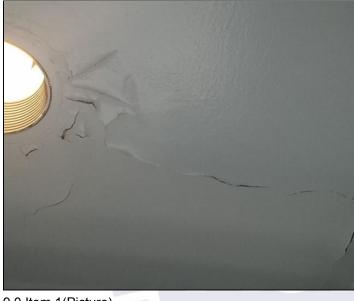
9.0 Item 1(Picture)

(1) Peeling paint is visible at the ceiling and wall areas. These areas are dry at this time however all painted surfaces in this home should be considered to contain lead unless proven different by a lead paint testing specialist. Prep and paint needed.

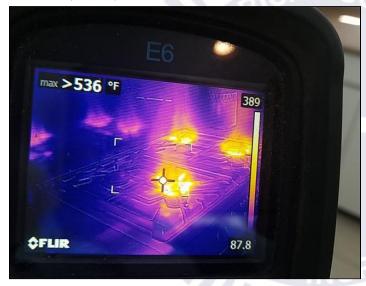
9.5 Item 2(Picture)

Left rear top burner did not light at the range requiring repair, and the wall oven display is difficult to see therefore I was unable to test this appliance.

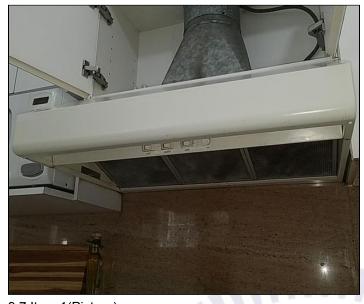
9.7 Item 1(Picture)

Functioning.

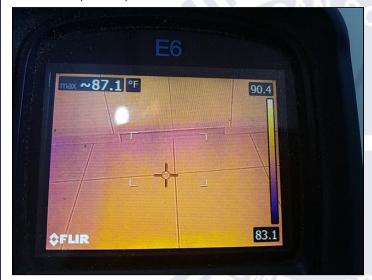
9.10 Item 2(Picture)

Electric baseboard heater under the cabinet did not function and the control knob is loose at the wall.
Repair recommended.

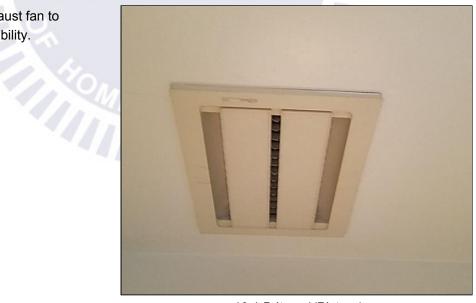
10.1.B Item 1(Picture)

Clean and maintain exhaust fan to help prolong its serviceability.

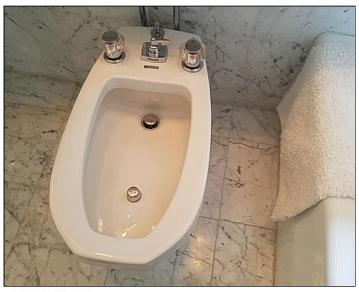
10.2.C Item 2(Picture)

(2) Water was off therefore not tested.

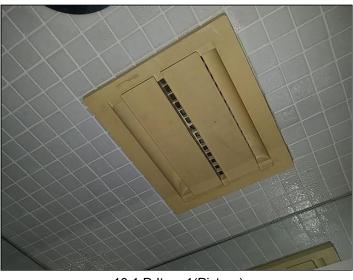
10.1.D Item 1(Picture)

Clean and maintain exhaust fan to help prolong its serviceability.

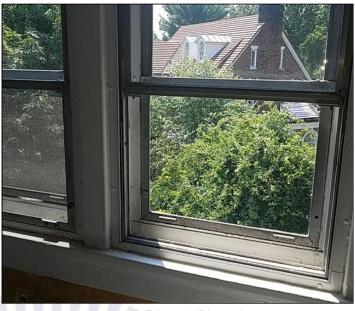
10.1.E Item 1(Picture)

Window ventilation present.
